**Second  
International Conference  
on  
Case Histories in  
Geotechnical Engineering**

**June 1-5, 1988**

**University of Missouri-Rolla  
Rolla, Missouri**

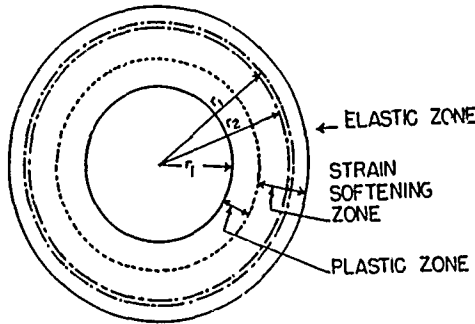
Fig.2 Assumed Zones Around the Tunnel

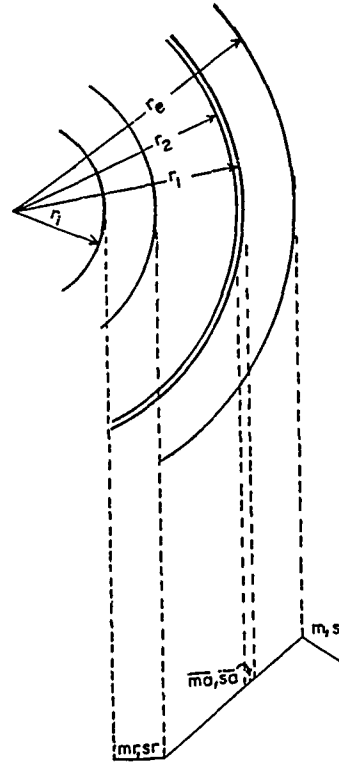
Fig.3 Interpolation for the Values of  $m$  and  $s$  in the Strain-Softening Region.

5. The rock mass is assumed to be linearly elastic with Young's modulus  $E$  and Poisson's ratio  $\mu$ , until the initial strength for the appropriate value of  $\sigma_3$  is reached. Thereafter the strength gradually drops with increasing strain as shown in Fig. 3. Strength reduction from the peak and continued deformation at residual strength are accompanied by plastic dilation. Some elastic volume increase may also occur when the stresses are reduced. These aspects are covered in the appropriateness of constants  $\alpha$ ,  $h_1$  and  $h_2$ .

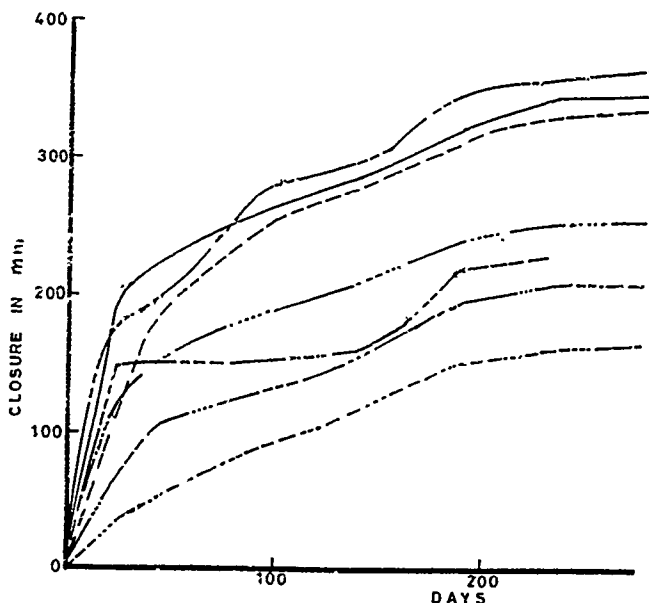
Fig.4 Giri Project - Closure vs. Time for a Zone with Loose Packing

In some reaches, the closures continued even after 300 days, though at a much reduced rate. Figs.4 shows typical closure observations with respect to time, for reaches with loose packing.

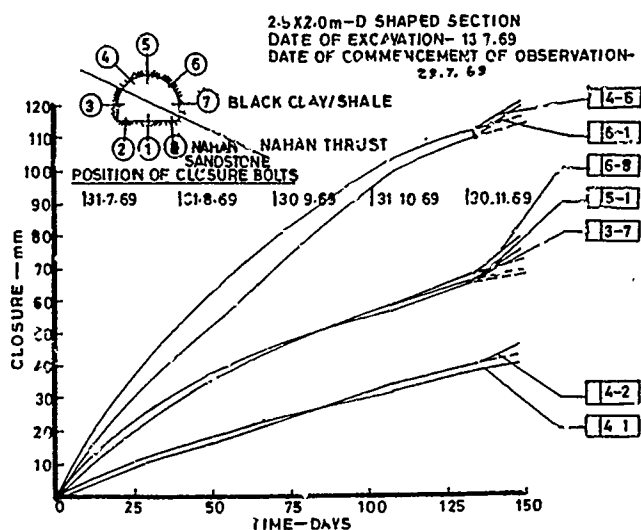
Fig.5 Yamuna Project : Time-Closure Relationship

The borehole extensometers showed an extension of about 30mm. The depth of anchors was only 3 metres in this study which is just equal to the tunnel diameter, hence a limitation. Fig.5 shows time-closure relationship.

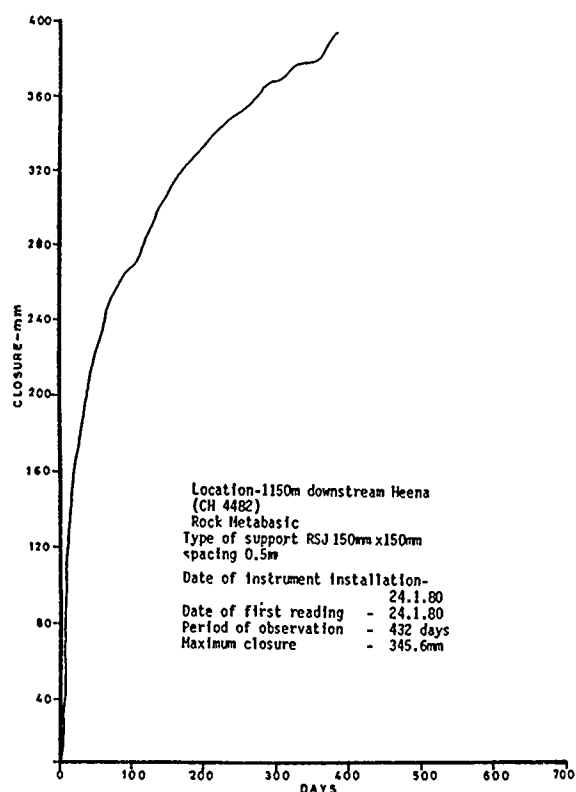
Fig.6 Maneri Bhalī Project - Closure Observations at Chainage 1150

Closures and rock loads have been measured at a number of locations; for the present purpose, we would consider a reach in metabasics which is located between chainages 1000-1200 from Heena adit. The observed closures are plotted and shown in Fig. 6. It is seen that even after a closure of about 380 mm, the system has still not stabilised. A rock pressure of the order of 4 kg/cm<sup>2</sup> has been recorded.

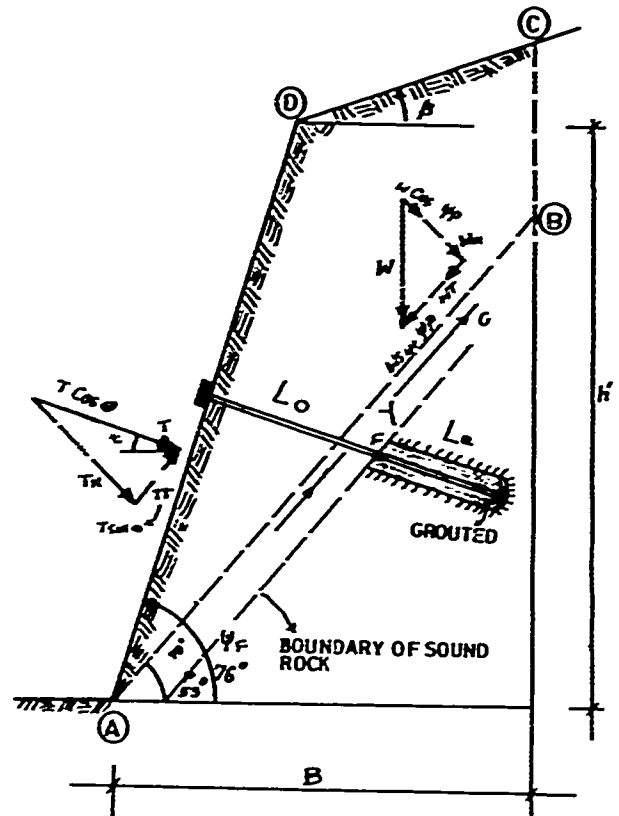
## DESIGN MODEL FOR ROCK-ANCHORAGE

## EQUILIBRIUM CALCULATION FOR ROCK MASS A-B-C-D. MECHANICAL PARAMETERS FOR THE ROCK

B-C = Most dangerous vertical crack (B)

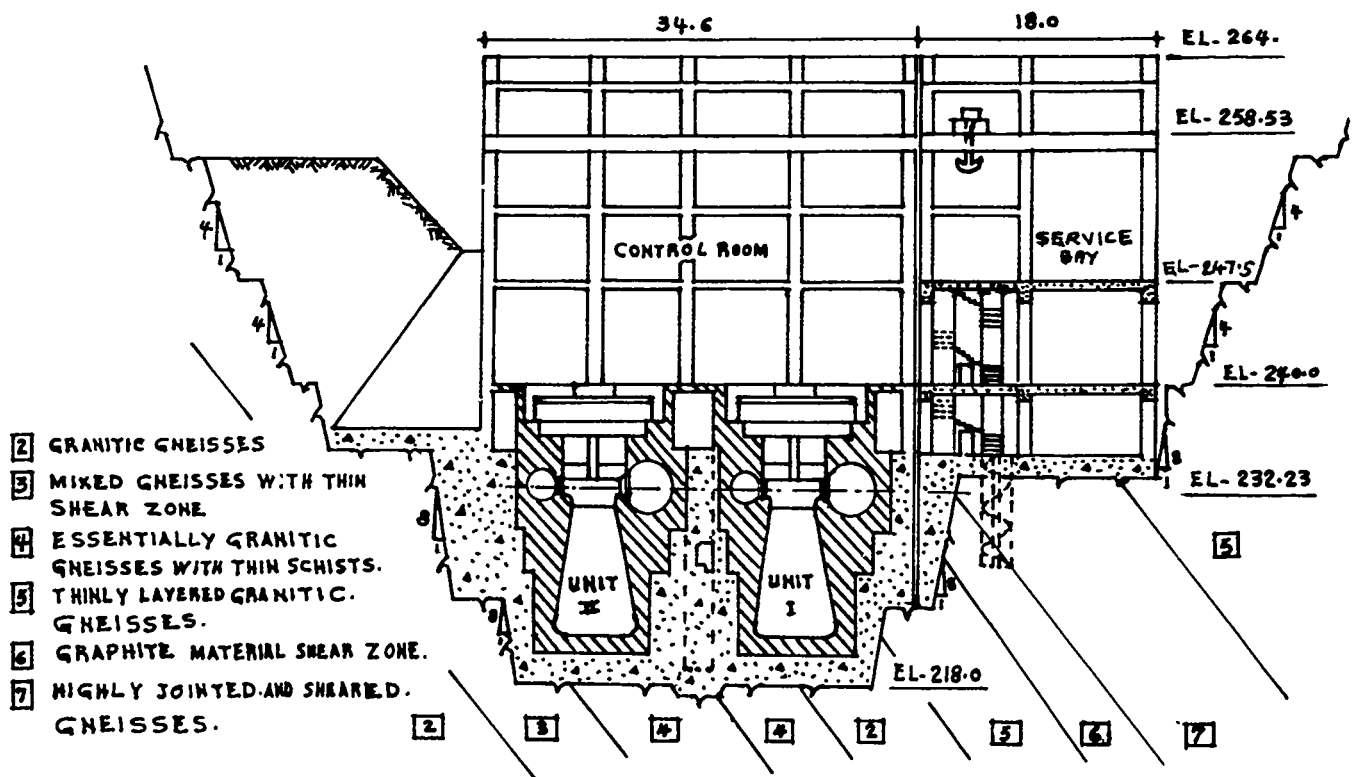
Fig. 2 Section of power house as per original plan.

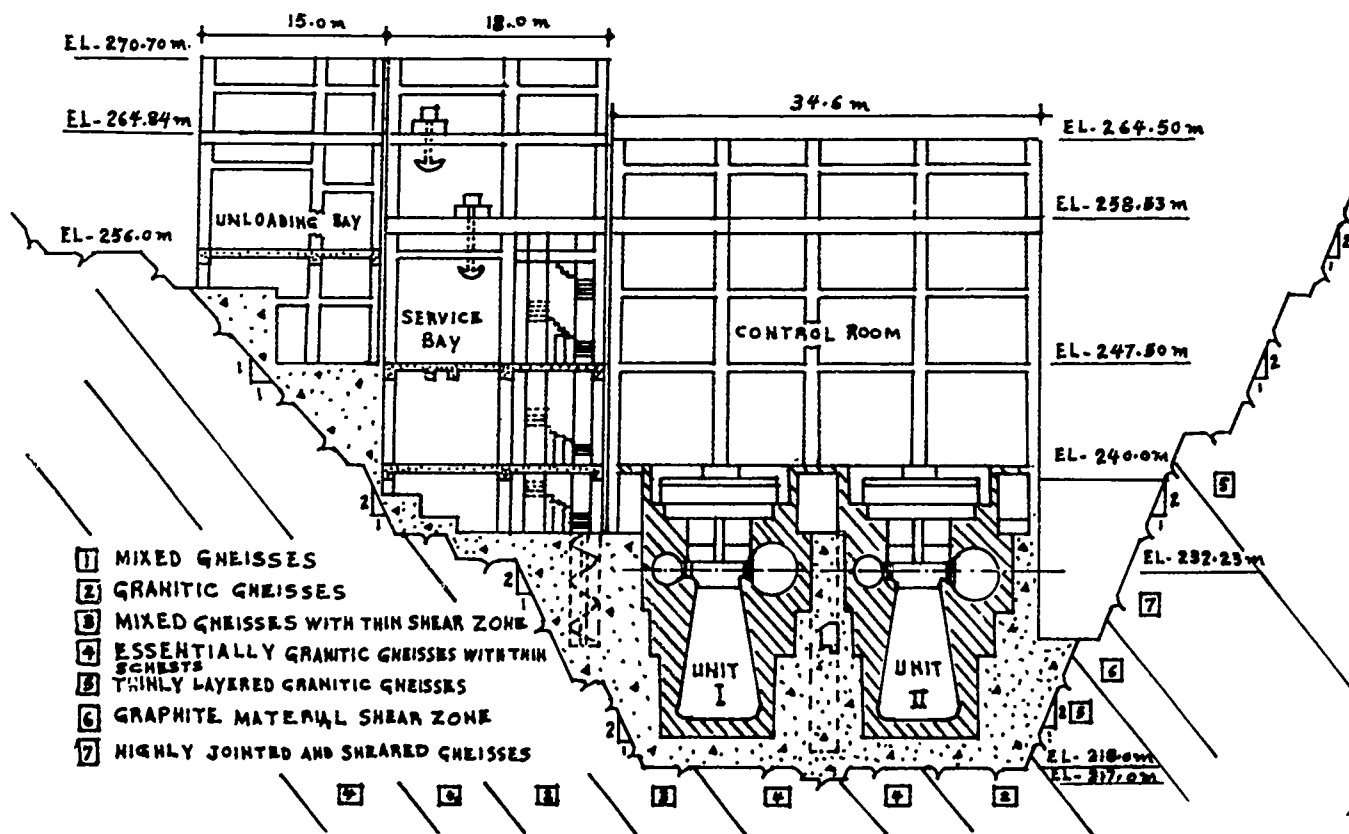
Fig. 6 Section of power house as per revised plan.

Since direct access upto this level was practically not possible, idea of two level service bay was conceived and one additional floor 10 m wide at El-256.0 m was proposed to work as unloading bay. Service road from main highway was arranged upto this unloading bay at El-256.0 m by locating it along by-pass channel. Earlier only one E.O.T. crane was sufficient for this power house but now due to addition of unloading bay at higher level, it became necessary to provide one more E.O.T. crane to operate between unloading bay and service bay. The roof of the power house had also to be arranged in two levels.

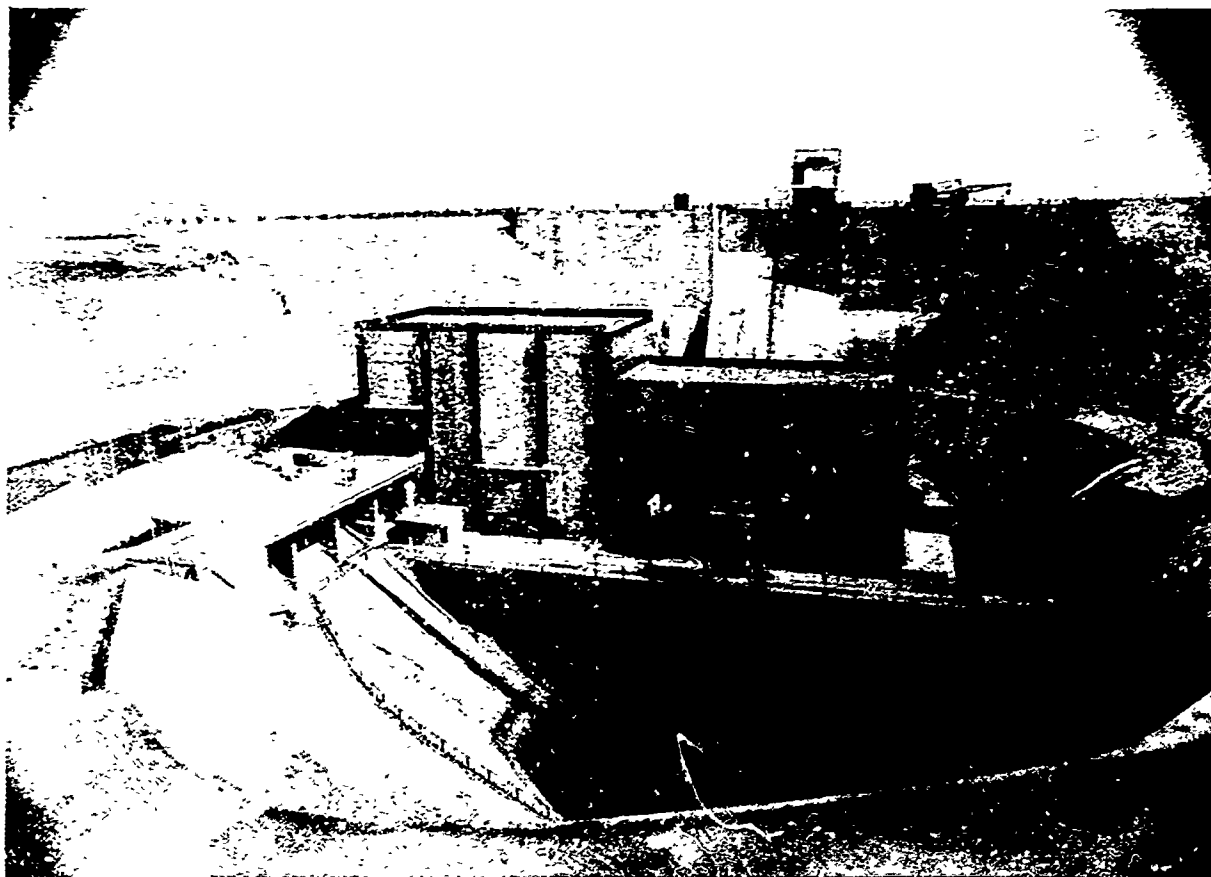
Fig. 7 General view of Power House.

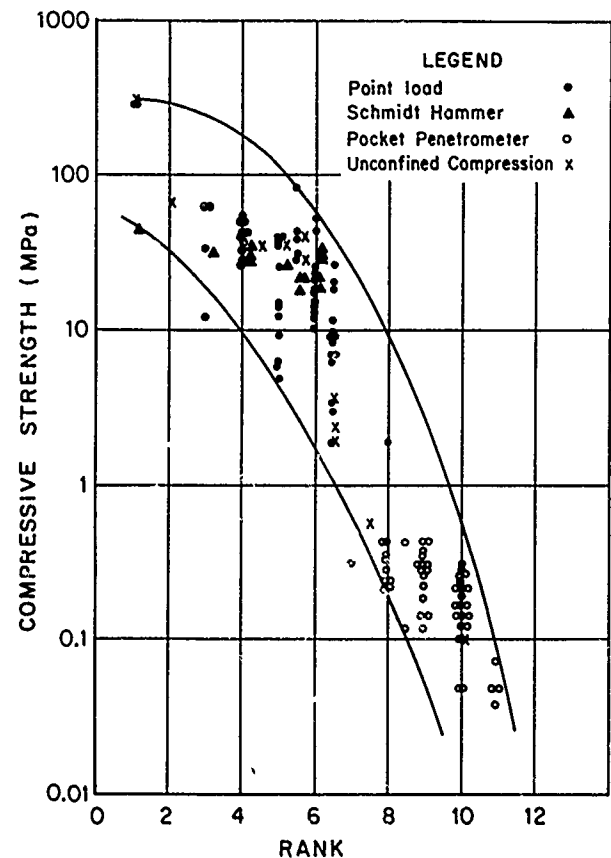
Figure 3. Unconfined Compressive Strength Versus Rank of Material From Scanline Surveys (C. Mirza Engineering Inc., 1986)

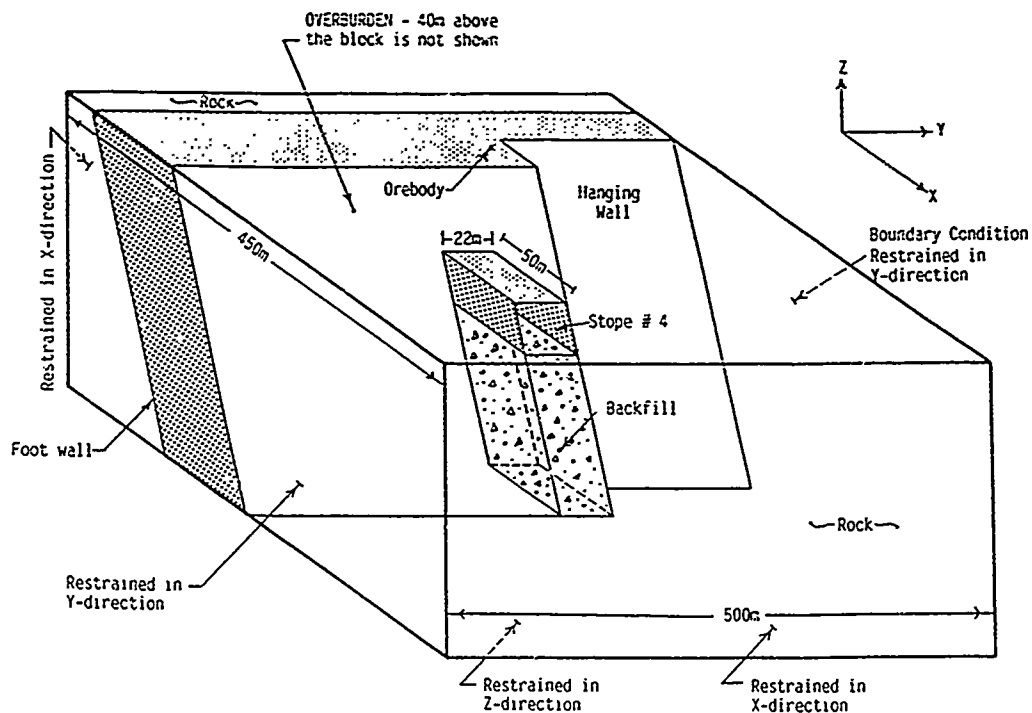
Figure 4. Numerical Model Layout, to Simulate Stope 4 Cave-in (Strata Engineering Corp., 1987)

The numerical model chosen was a multi-dimensional finite element program capable of accepting Mohr-Coulomb type elements, with a 'birth' and 'death' option for each element. Two dimensional modelling was found to be inadequate, and all subsequent modelling was three dimensional. The failure mechanism adopted, based on the authors' previous experience and research (Bétournay, 1980), was as follows. The soil-like mass is held together around an opening by negative pore pressure, induced by the creation of the opening. With time this condition dissipates at the boundary leading to tensile failure, a mechanism which progresses upward. In order to

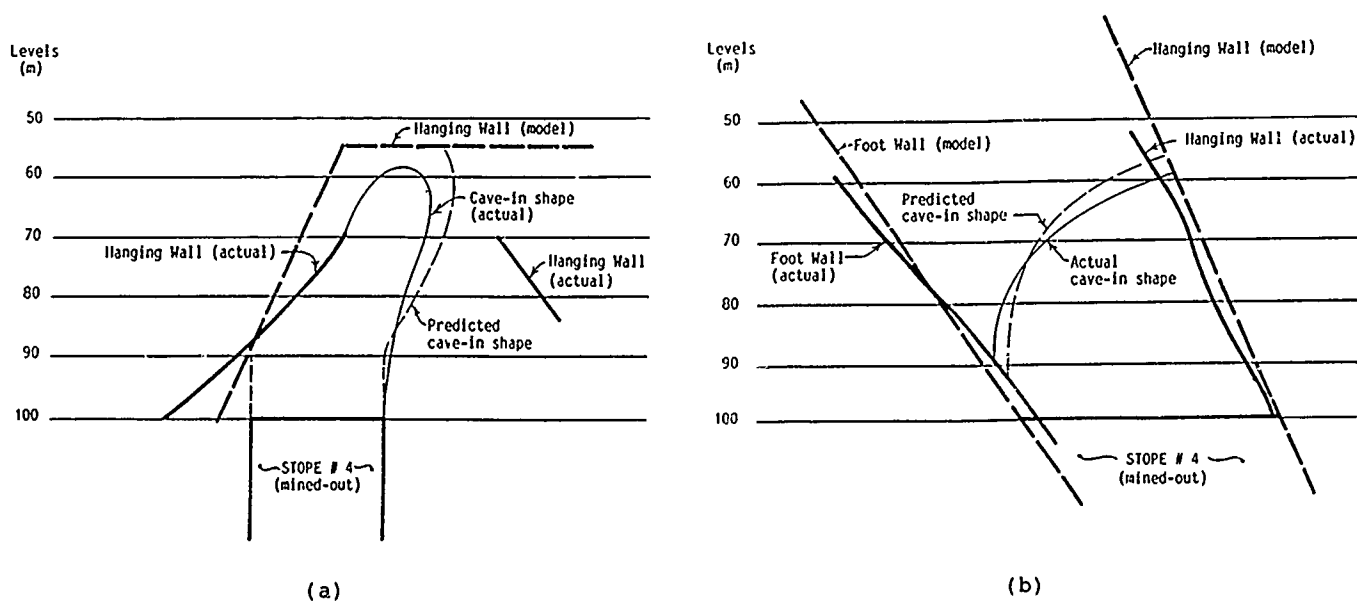
Figure 5. Numerical Model Prediction of Stope 4 Failure vs. Actual Failure  
(a) Along Strike, (b) Normal to Strike (Strata Engineering Corp., 1987)

accommodate tensile failure, gravitational forces were applied in ten computational steps, which enabled the analysis to be halted as to eliminate all tensile failed elements (by changing the status of the failed elements into unborn elements), and the analysis was continued until full gravity loading was reached. The remnant rock pieces were too small to affect the stability as failure mechanism of the soil-like material.

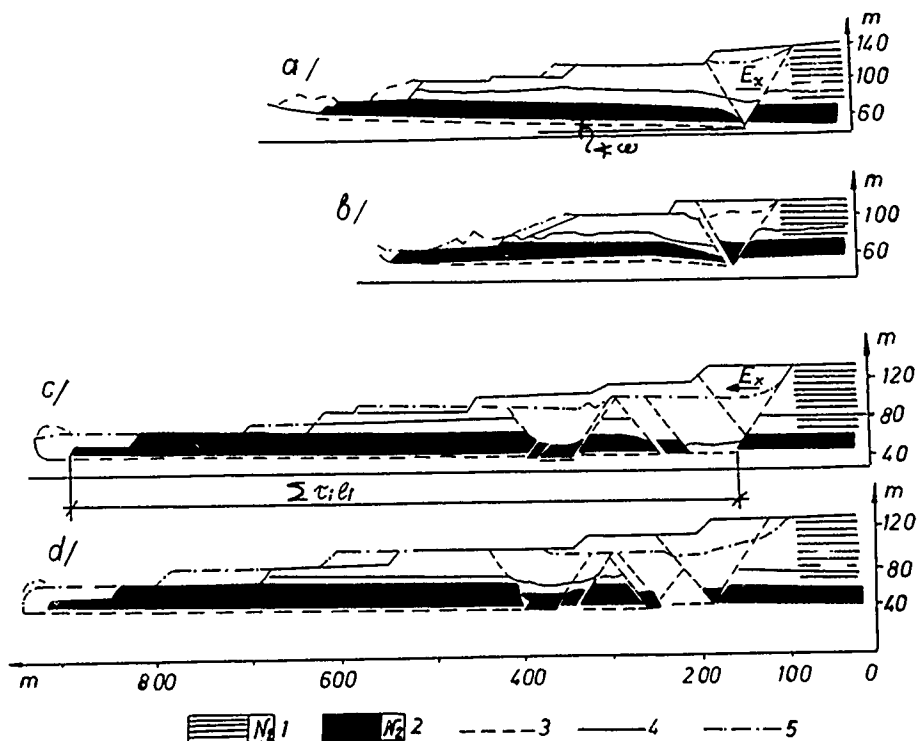
Fig. 2. Schematic Profiles of the Great Landslides in the East-Maritza Open-cast Mines in 1966 ( a, b) and in 1968 ( c, d)  
1- Pliocene Clays; 2- Coal Seams; 3- Landslide Surface; 4- Line of the Profiles of Flanks before the Landslides; 5 - Line of the Profiles of Flanks after the Landslides.

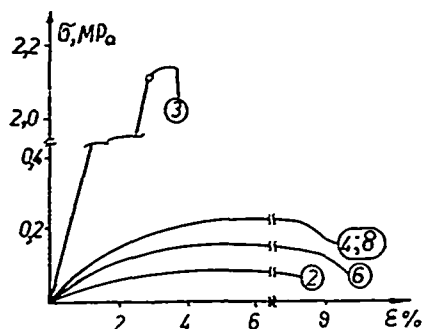
Fig. 3. Relationships "stress-strain" for the clays of the East-Maritza basin (the numbers of the curves correspond to the Numbers of the clays from fig. 2).

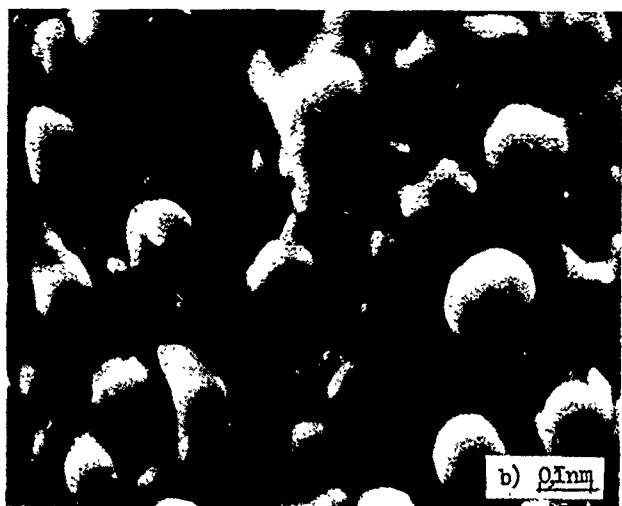
Fig. 4. SEM images of clays from the sliding surfaces

- a/ a general view of the clay minerals and humine acids
- b/ Humine acids

In our opinion, these paradoxes are determined from the paradoxal strength and deformation properties of the clays from the major sliding surfaces - i.e. the most weak unconsolidated greyish-black clays interlayering the coal seams (fig. 1, 2, 4). If the maximum values of the deviator stresses  $(\sigma_1 - \sigma_3)_{\max}$  or the plane shear stresses  $(\tau_{\max})$  are used for plotting the relationship  $\tau = f(\sigma)$  the following results are obtained (fig. 5).

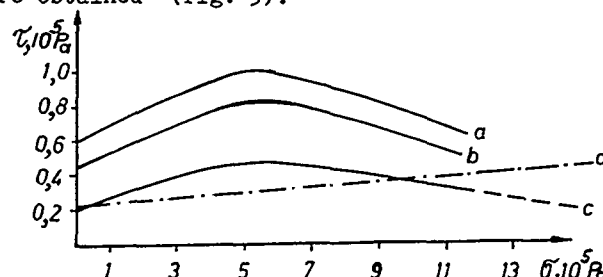
Fig. 5. Relationships "shear stress - normal stress" for greyish-black clays from the main sliding surfaces, obtained from:

- a/ maximum deviator stresses
- b/ ultimate deviator stresses
- c/ allowable deviator stresses
- d/ back analysis of initial landslides stability

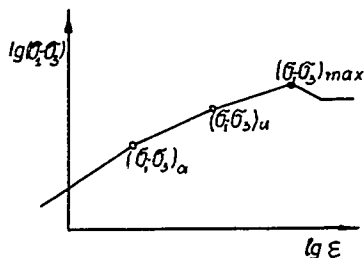
Fig. 6. Relationships "stress-strain" for clays from sliding zones

Analysing the microfabric and physical properties of these clays with close coagulation contacts, it was ascertained that they should be considered as a special structural and mechanical type, for which the classic ideas of soil mechanics are not valid. We gave up using the traditional strength parameters  $\varphi$  and  $c$  as characteristics of strength properties of these clays. Instead of them, there were accepted the so called "allowable"  $\tau_a$ , ultimate  $\tau_u$  and maximum shear stresses  $\tau_{max}$  obtained through the analysis of the relationships  $(\sigma_1 - \sigma_3) = f(\epsilon)$  in logarithmic scale (fig. 6).

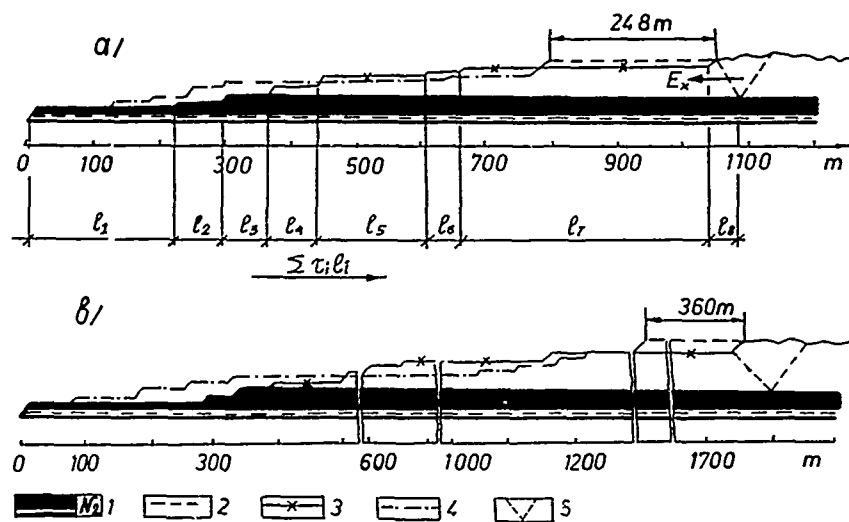
Fig. 7. Technological Profiles of the Working Flanks in the Troyanovo-South Opencast :  
 a) profile III - second quarter of 1981  
 b) profile 43 - second quarter of 1981  
 1 - coal seams; 2 - shear planes for which the pit edge stability is determined;  
 3 - line of working flanks along which the coal winning is done; 4 - line of the  
 S profile; 5 - zone of active pressure

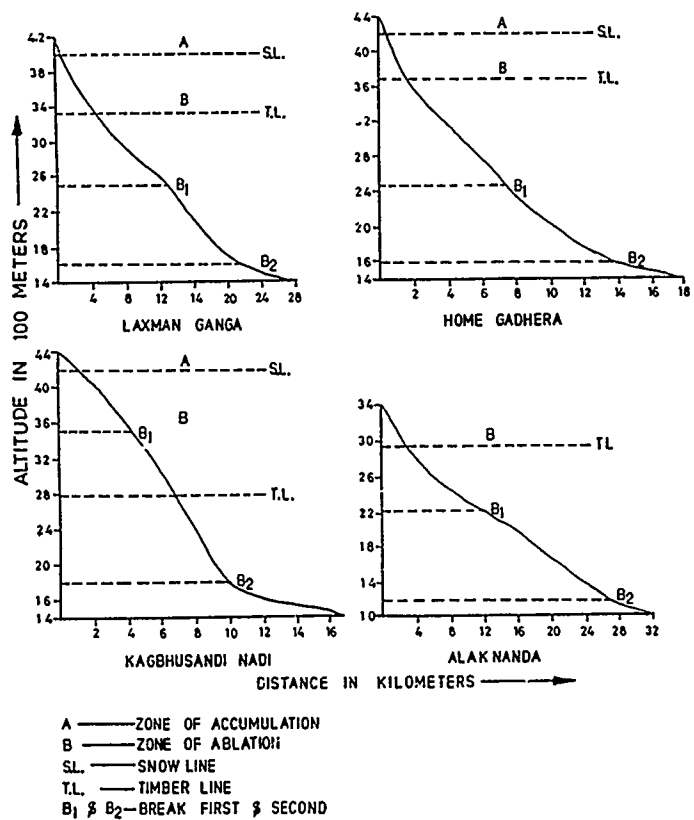
Fig.7—SLOPE PROFILES OF THE RIVERS

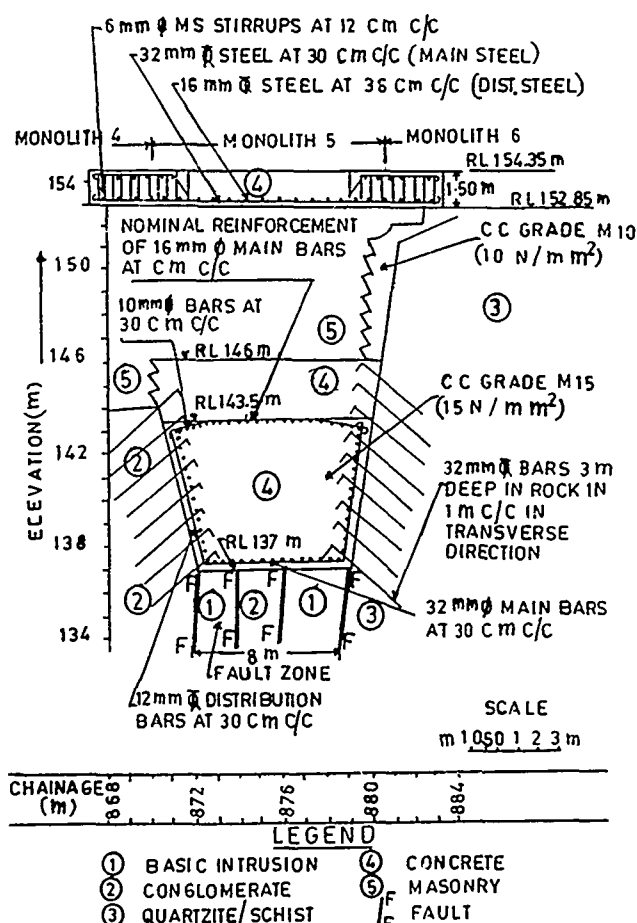
FIG. 4: FAULT ZONE TREATMENT IN MONOLITH 5

(b) Fault zone encountered in monolith 5 being a major one, elaborate treatment was considered imperative. Because of an 8 to 8.5 m wide fault zone traversing across the dam axis, a separate monolith had been provided. By adopting the Shasta formula for the plug treatment, the depth of excavation worked out to 6 m from the general foundation level at RL 143.5 m. Accordingly, the fault zone material was excavated down to RL 137 m where it was revealed that the clayey gauge was the decomposed product of basic intrusive along the fault zone. The excavated trench has been plugged with M 15 (15 N/mm<sup>2</sup>) strength concrete. To transfer the load to the competent shoulders, arch shaped concrete has been done. Hammock reinforcement of 32 mm diameter deformed bars placed at 30 cm both ways has been provided to take care against any settlement. This has been extended upto RL 143.5 m. Above this and upto RL 146 m concreting is done (Fig. 4).

The left shoulder of the fault zone trench is formed by conglomerate whereas the right one is made up of competent quartzite interbedded with thin schist bands. The sides of the trench were roughened to have proper bond between the concrete and the rock. Contact grouting has also been done to take care against shrinkage, etc.

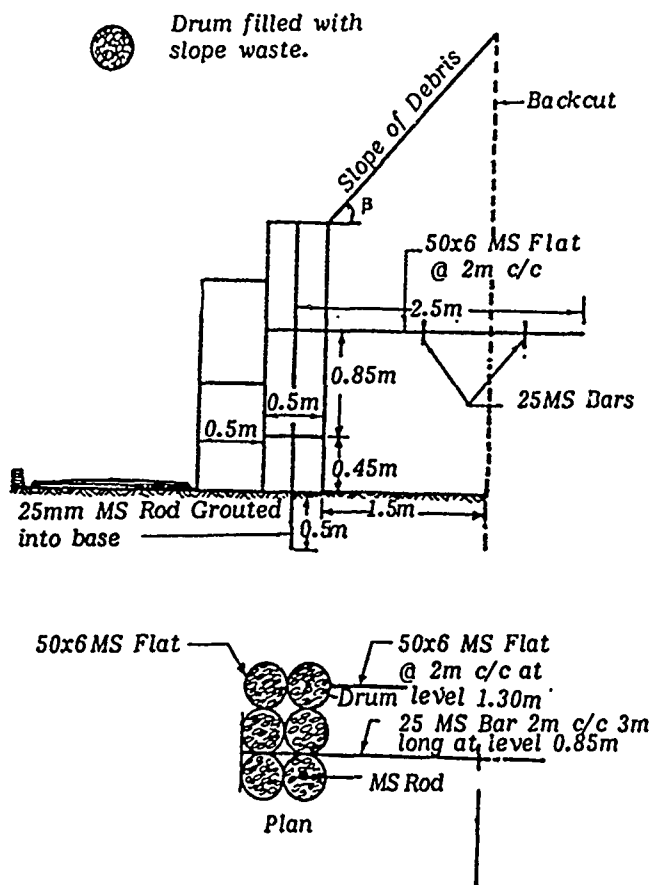
FIG. 2 ANCHORED DRUM DIAPHRAGM WALL BUILT OF SLOPE WASTE AND EMPTY BITUMEN DRUMS

stability by Finite Element Method assuming it as a plane strain problem. A typical drum diaphragm wall is built of slope waste placed into empty bitumen drums which are anchored using 25 mm dia mild steel bars grouted into the foundation to a depth of 0.6 m. The diaphragm is anchored to the slope with the help of 50 x 6 mm m.s. flat at 2 m centres 2.5 m into the slope.

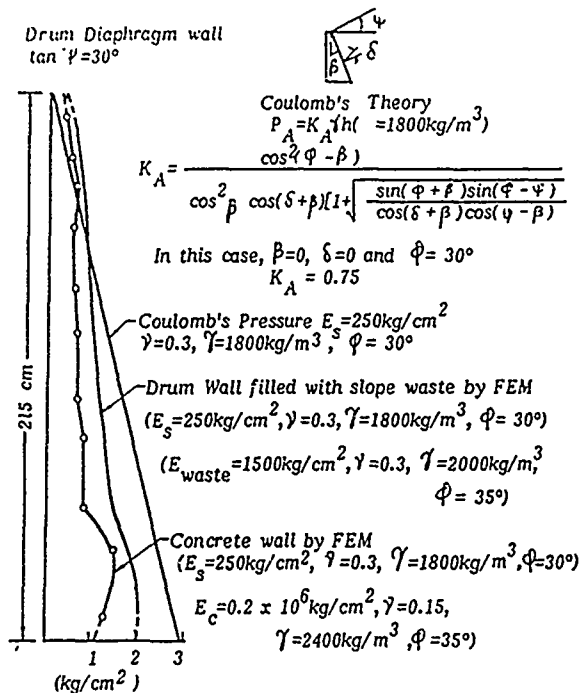
FIG. 3 EARTH PRESSURE DISTRIBUTION

Fig. 3 shows the distribution of horizontal earth pressure, Fig. 4 the horizontal displacement of the drum diaphragm wall obtained by the finite element analysis and the same has been compared with that obtained by Coulomb's theory. The slope of surcharge of the retained material has been taken as  $30^\circ$ .

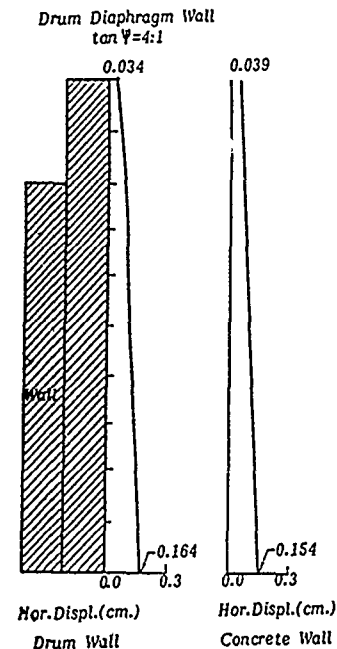
FIG. 4 HORIZONTAL DISPLACEMENT OF WALL

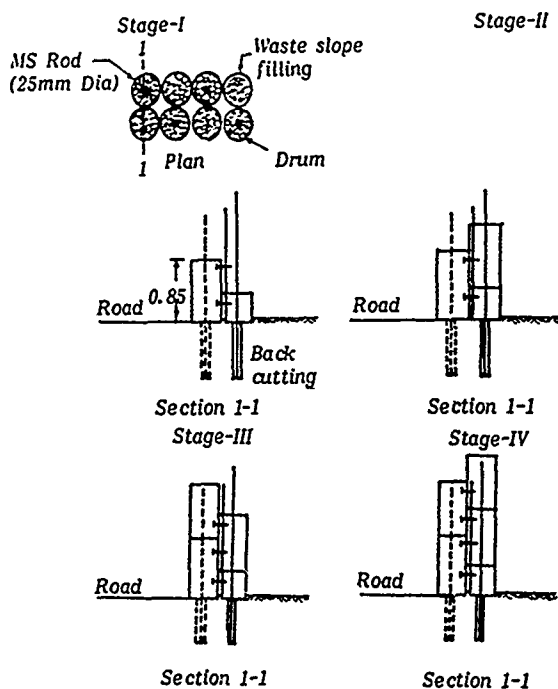
FIG. 5 SEQUENCE OF CONSTRUCTION OF ANCHORED DRUM DIAPHRAGM WALL

As the construction of drum wall continues, the already completed portion of the wall is filled with debris which provides mass to the wall. The space behind the retaining wall is filled with debris. A 50 mm x 6 mm flat having a 28 mm dia hole at the centre is held against two drums of the front row. An L-shaped 25 mm dia, 3 m long m.s. rod is inserted into the hole and driven into the debris. This system is provided at 2 m centres to keep it in a proper alignment and to provide additional stability.

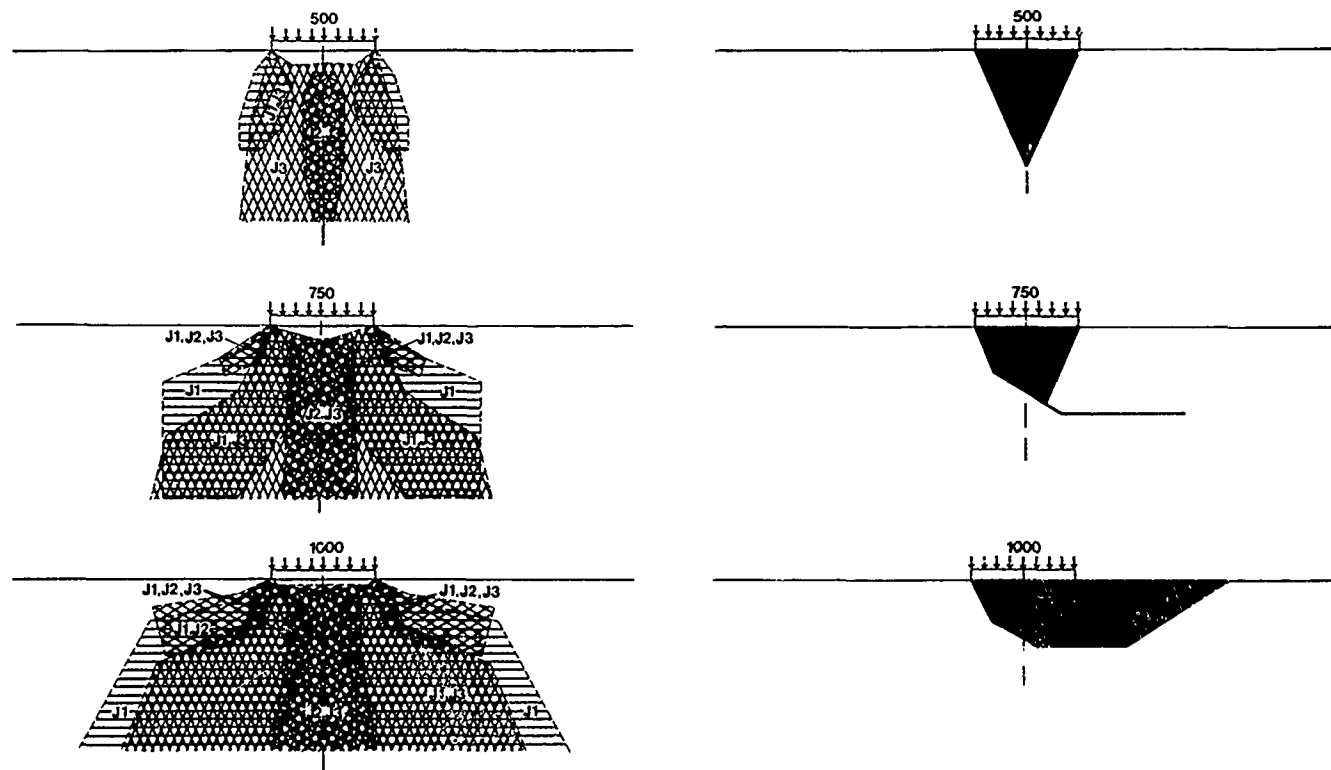
Fig. 2. Plastic zones of joint sets in the critical section. Failure form and sliding body. The joint sets are filled by clay filling material with mechanical parameters  $\phi_f = 0$ ,  $c_f = 95,0$  kN/m<sup>2</sup>.

plastic zones with the size of the load in the figures. Plastic zones, which have common areas, are developed for relatively bigger loads for the two or for the three joint sets (Fig. 2). The further load increase conducts finally to unfavourable combination of the plastic zones of the joint sets with consequence the creation of a sliding body and the failure of the foundation.

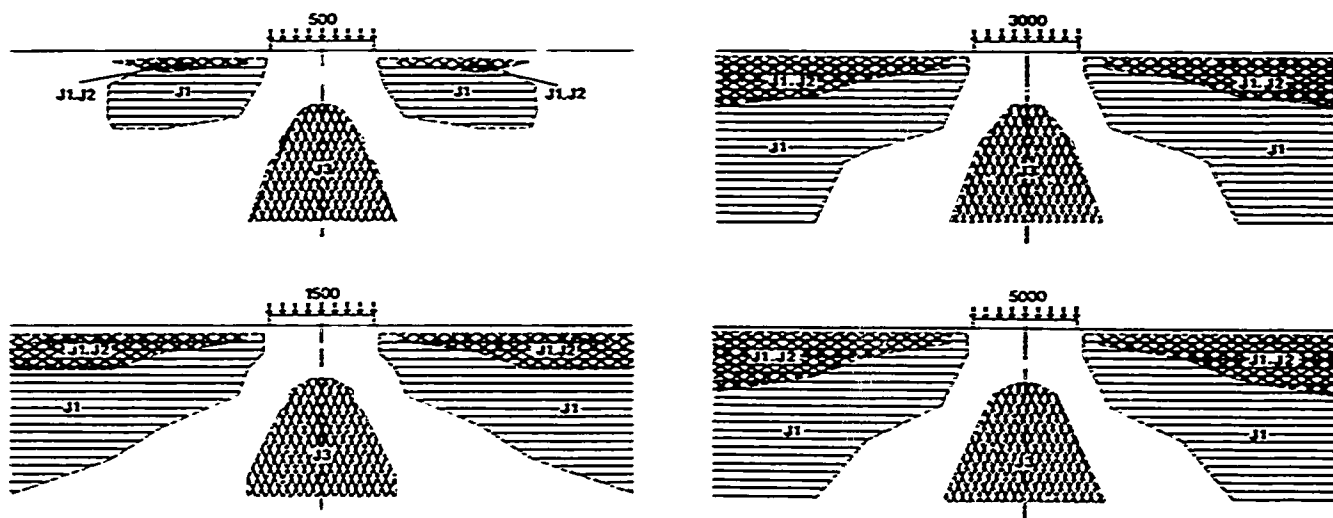
Fig. 3. Plastic zones in case where the joints of rock mass don't contain clay filling material.

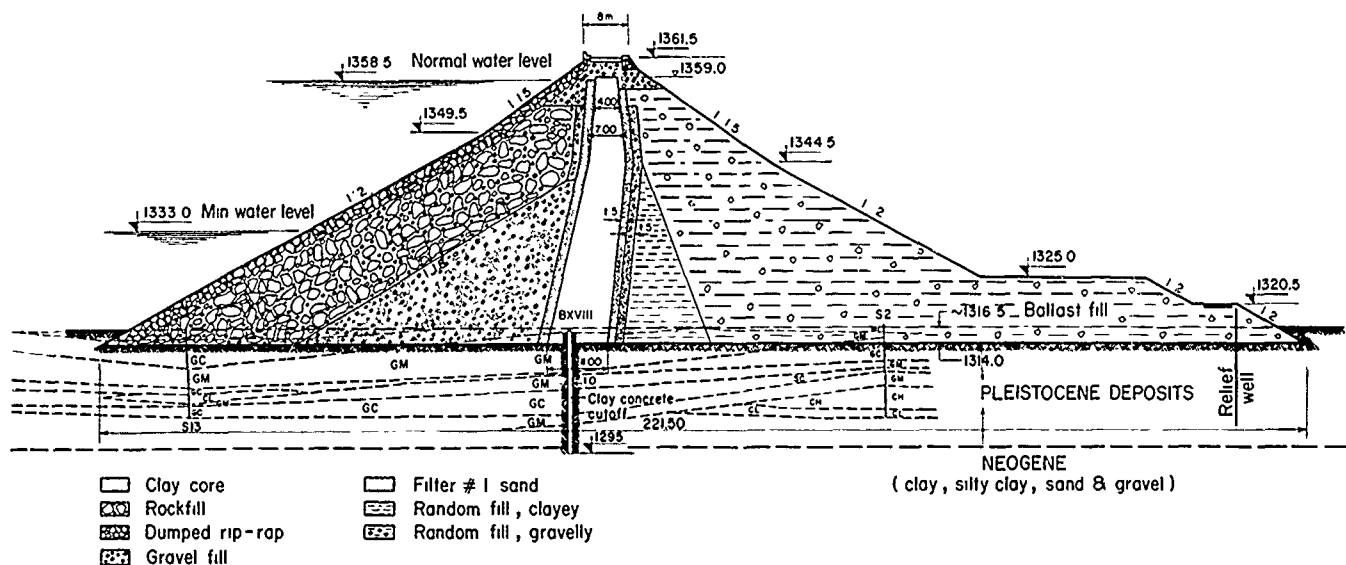
Fig. 2 Cross-section of dam showing material zones

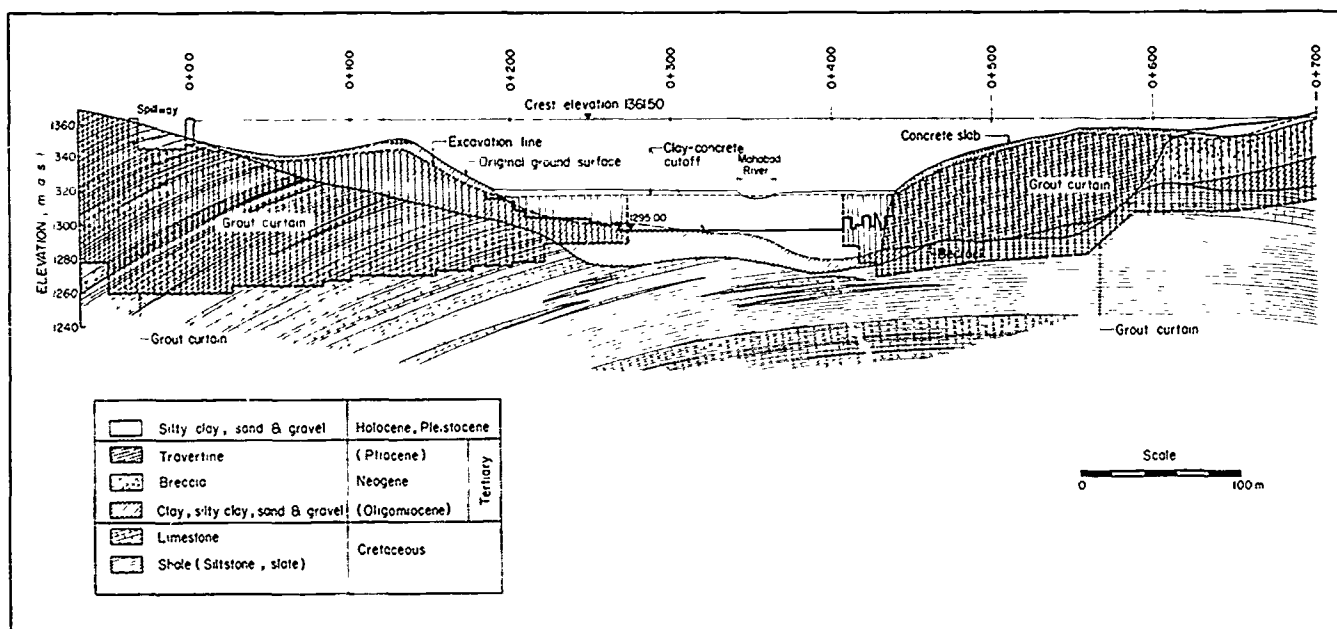
Fig. 3 Longitudinal section along dam axis (looking D/S) showing geology, grout curtain and cutoff

Lithostratigraphy. - Basically, the dam site consists of Cretaceous rocks underlying Neogene deposits which in turn are overlain by Quaternary deposits. The original width of the river plain was about 250 m. Figure 3 shows a cross-section through the valley and dam abutments along the dam axis.

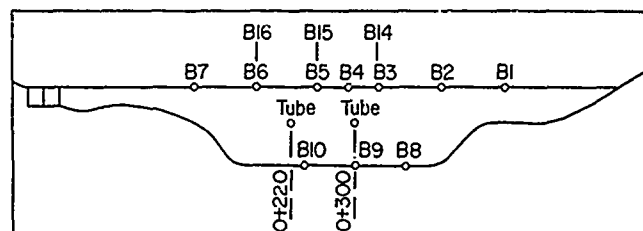
Fig. 4 Longitudinal section showing locations of benchmarks and settlement tubes

- Seven target points (or benchmarks) B1 to B7, located on the D/S curbstone of the crest between chainage 0+100 (B7) and 0+485 (B1).
- Three benchmarks, B8, B9 & B10 on the D/S

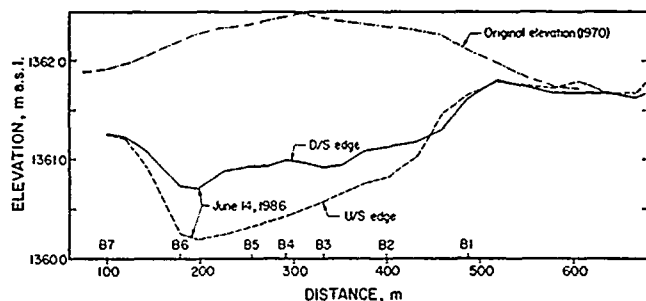
Fig. 6 Differential settlements of U/S and D/S curbstones along dam crest

- There is a considerable tilt of the road pavement towards U/S. The positions of the leveling points on the D/S and U/S curbstones are shown in Fig. 6, together with the original elevation, for June 1986. The largest differential settlement (tilt) between the two curbstones occurs at 0+226, and on June 14, 1986 it had reached 64 cm. (To get the pavement elevation, the height of the curbstone, usually 30 cm, must be subtracted). The camber at this

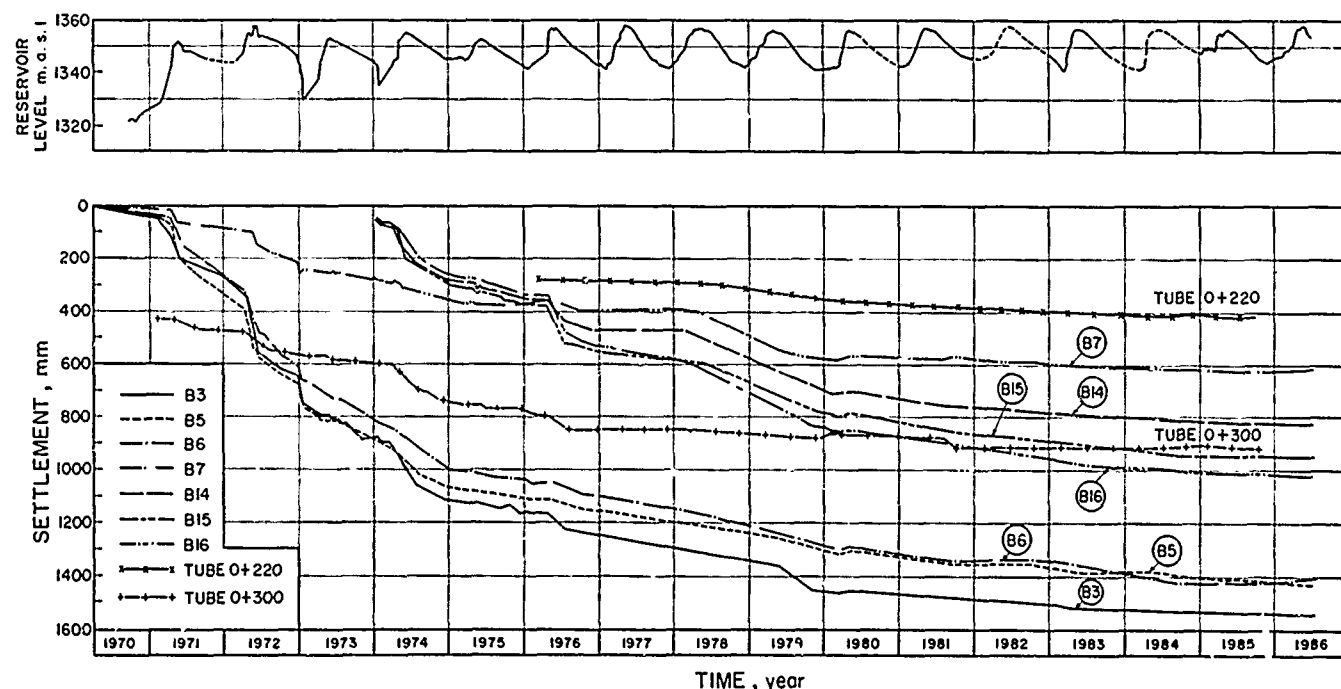
Fig. 7 Vertical components of displacement vectors (settlement) of selected points

For the vertical movements the first four filling and drawdown cycles are of particular interest. During the first year of impounding (1971) the reservoir level reached a peak of 1351. Settlement rates started to increase when the level had reached 1342.5. They decreased soon after the peak had been exceeded. During the second reservoir peak in 1972, settlement rates started to increase when the reservoir level reached El. 1353, and decreased again when it receded to El. 1355. Interestingly, an increase also took place during the very deep drawdown in winter 1972/73. Benchmarks B8, B9 & B10, on the other hand, showed a slight rebound of about 2 cm. No increase in the rates of settlement was observed during the following reservoir peak in spring 1973 which attained only El. 1353. A further increase occurred in summer 1974, especially also with the newly installed core benchmarks B14 to B16. It started when the reservoir level reached about El. 1345. Another increase in settlement rates can be noticed in 1976, but since then settlement rates have decreased steadily without showing a strong relationship with reservoir level fluctuations.

Settlement rates at benchmarks B8 to B13 remained quite small and were not affected by the reservoir level. Tubes 0+220 and 0+300 had a much reduced settlement rate when compared with B3 to B6

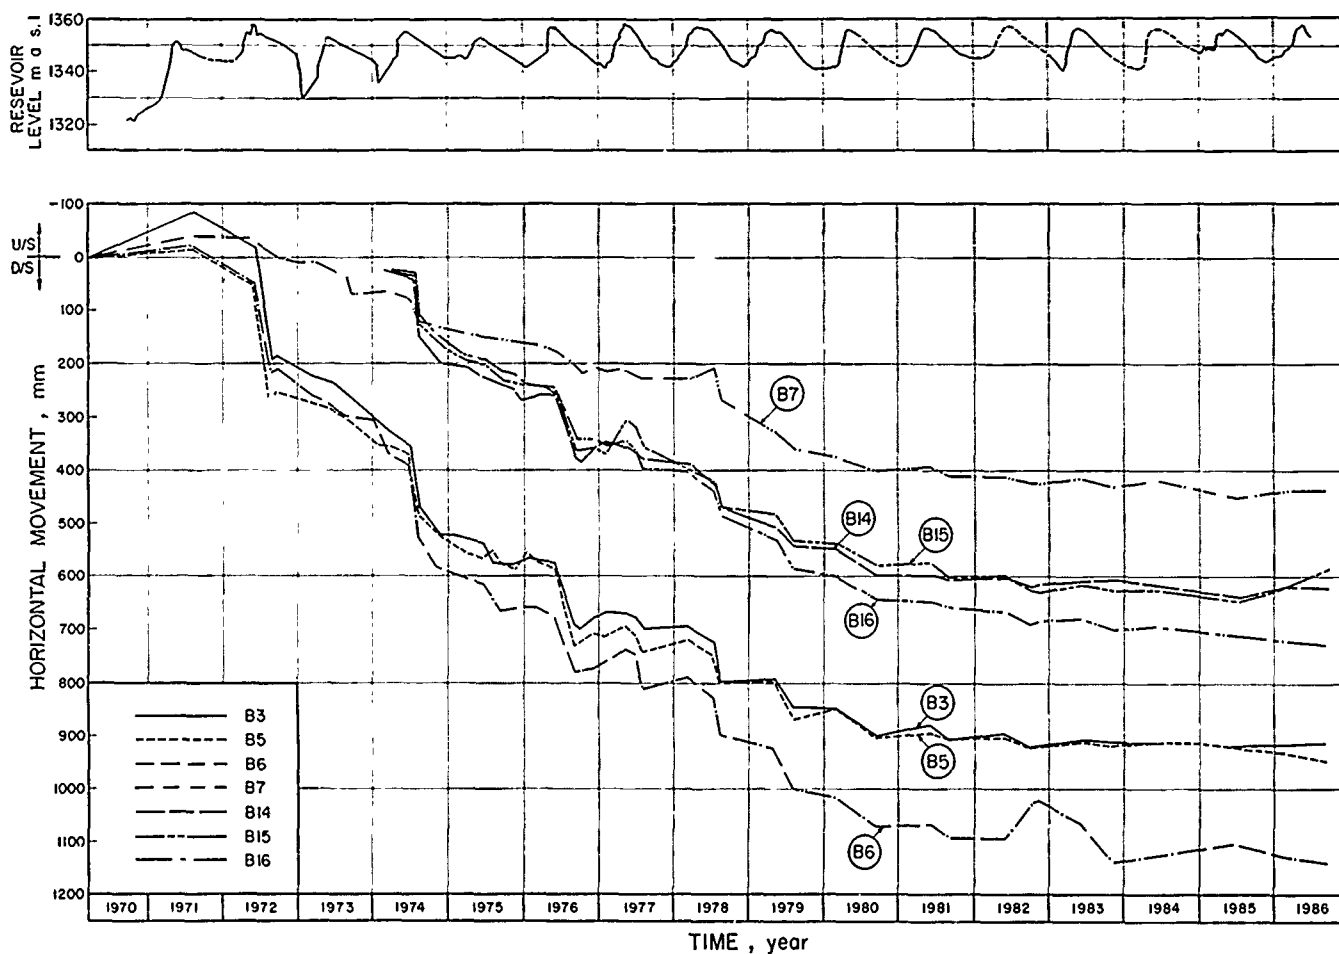
Fig. 8 Horizontal components of displacement vectors of selected benchmarks

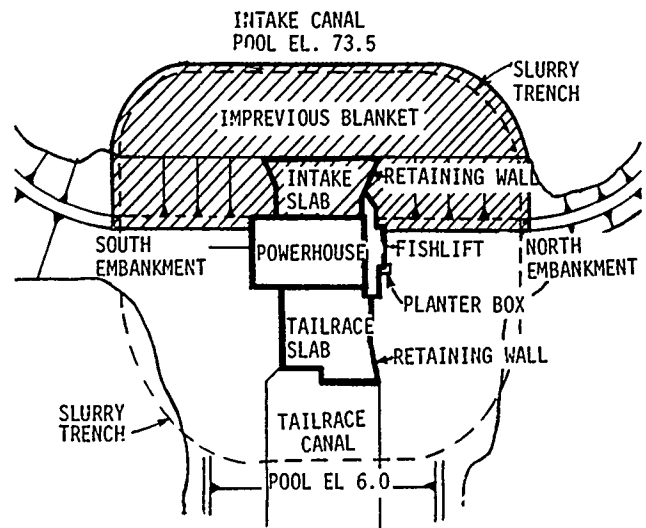
FIGURE 1

PLAN VIEW-POWERHOUSE AND APPURTENANT STRUCTURES

The powerhouse is tied into a system of levees on each side of the canal by a north and south embankment (reference Figure 1). The embankments are zoned fills with a crest elevation of 86. The invert of the intake canal is elevation 50 and the tailrace canal is elevation 0.0. With a normal pool at elevation 75 the embankments are subjected to a head differential of approximately 69 feet. A fishlift is incorporated into the north side of the powerhouse.
